# **The Performance of Low-Rise Open Span Heavy Steel Structures In Extreme Winds**

**Joe R. Charlton, B.S., P.E.**

**A REPORT**

**June, 1997**

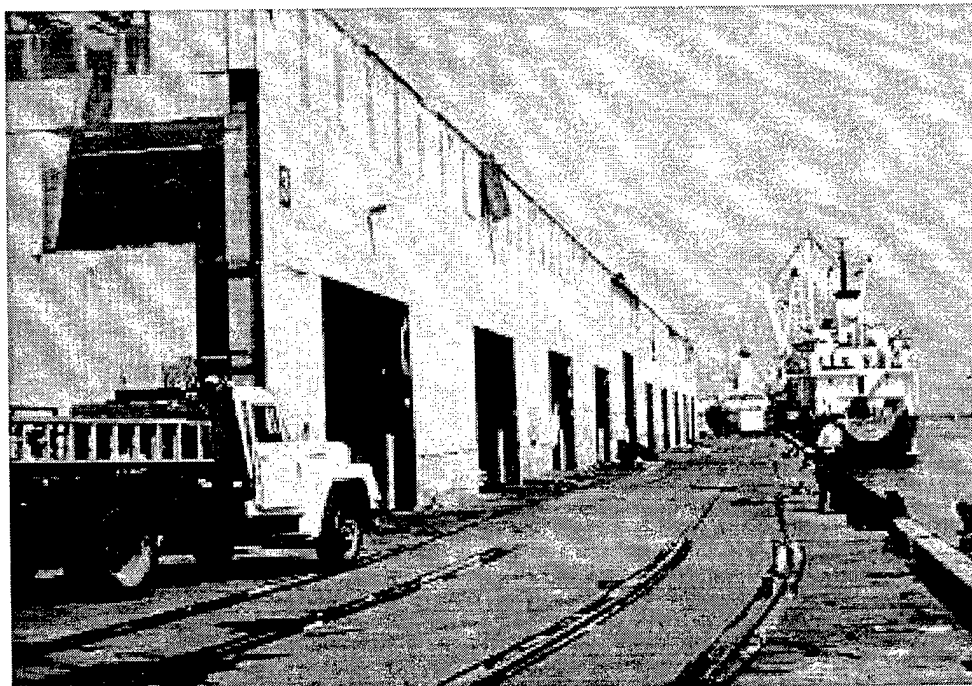
Figure 4.1 South Exterior Elevation of Building 3

This warehouse building sustained no significant structural damage, as can be seen in Figures 4.1, 4.2, and 4.3. The only damage noted was the failure of several large overhead doors and the removal of some of the corrugated metal roof and wall panels.

The probable cause of the roof and wall panel failure was the prior failure of the large overhead doors located on the side of the building running parallel to the railroad tracks, as seen in Figure 4.1. These overhead doors failed due to positive pressure

generated by wind blowing normal to the surface of the doors. Once the two overhead doors failed, the internal pressure inside the building increased and the roof panels and siding were torn from the structure due to the combined internal and external pressure.

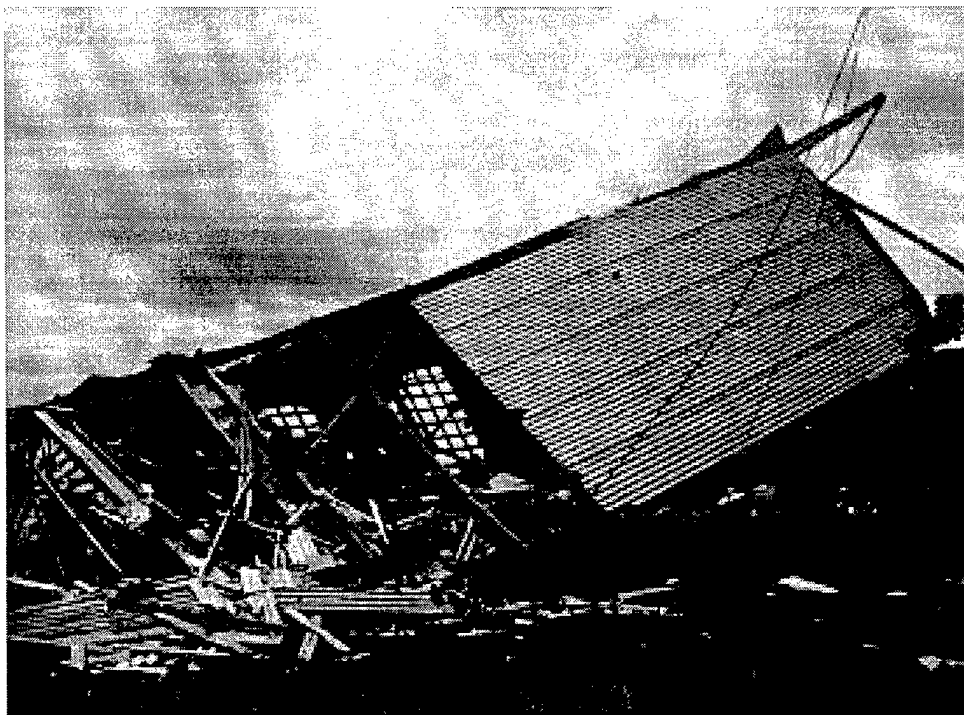
Figure 4.8 Failure of Parachute Tower

As seen in Figure 4.8, the parachute drying tower was totally destroyed by the Altus tornado. The failure of the tower was caused by excessive wind loads on the windward and leeward walls. These wind loads were sufficient to cause the anchor bolts on the southeast and northeast columns to fail in tension. Once the anchor bolts failed, the overturning moment generated by the easterly wind caused the building to rotate about the other two columns and collapse. A close up of the anchor bolt failure can be seen in Figure 4.9 and a close up of the column base plate in Figure 4.10. Figure 4.10 shows definitively that the base plate did not fail.

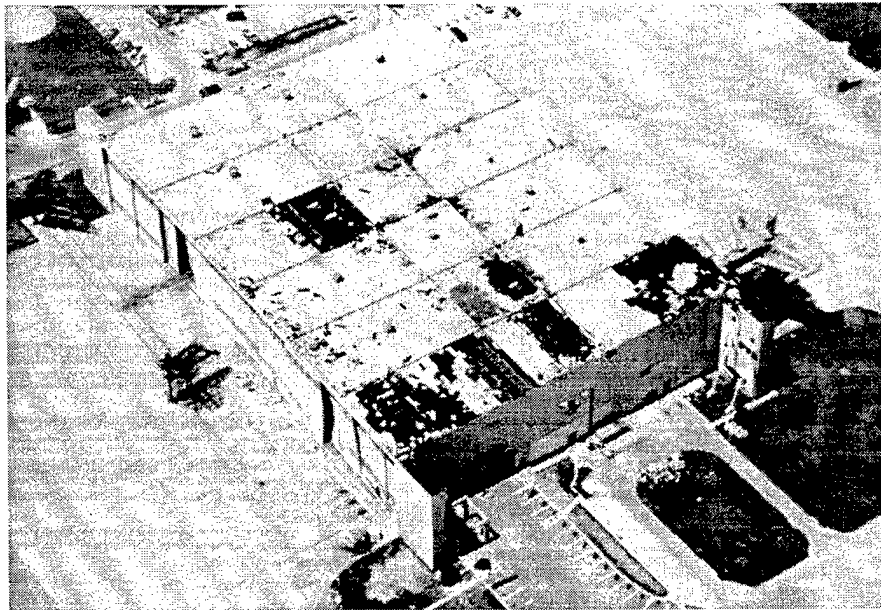
Figure 4.12 Aerial View of Damage to Building 285

Overall, the hangar performed well when subjected to these severe winds. The exterior corrugated asbestos siding performed well and experienced only localized failure. There were no failures noted in the heavy “C” channel wall girts or the roof trusses supporting the corrugated siding and the roof decking, respectively. No failures were noted on the main structural elements. The only damage to this building was the removal of a portion of the roofing material and the roof decking, structural damage to two rail mounted hangar door sections, and the removal of exterior corrugated siding along the door pockets. The damage to the hangar is shown in Figures 4.12 through 4.17.

The majority of the damage to the roof covering seen in Figure 4.12 is along the edges of the roof line. This damage is consistent with the higher suction pressures that are typically experienced at the leading edges of a structure with a flat roof. One other factor that may have precipitated the damage to the roof membrane is the partial failure of

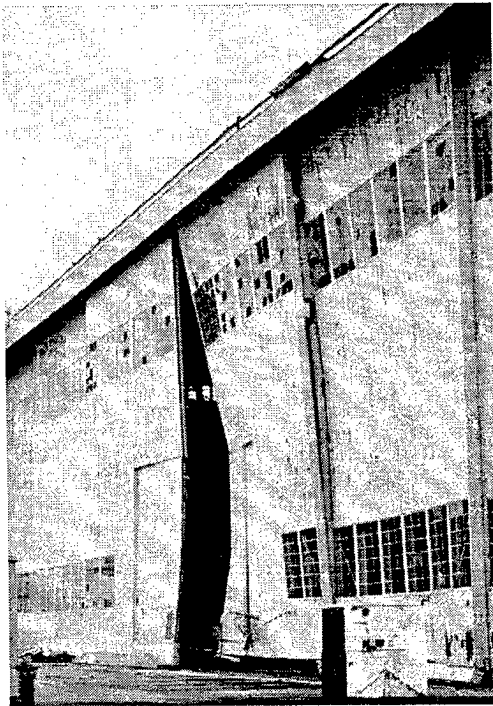
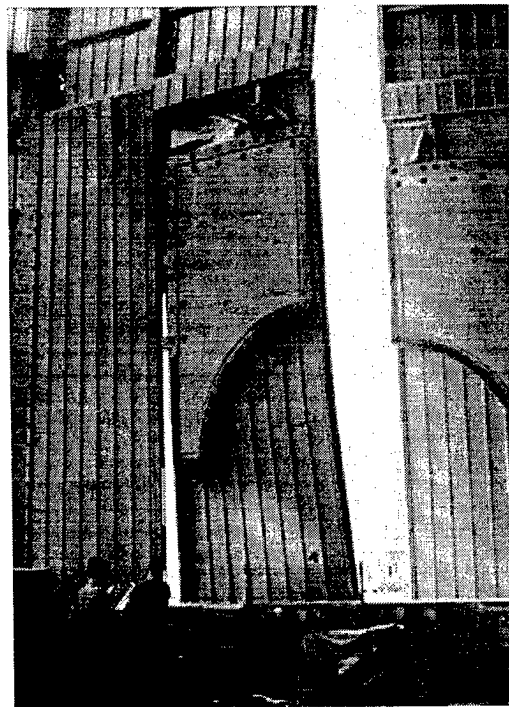
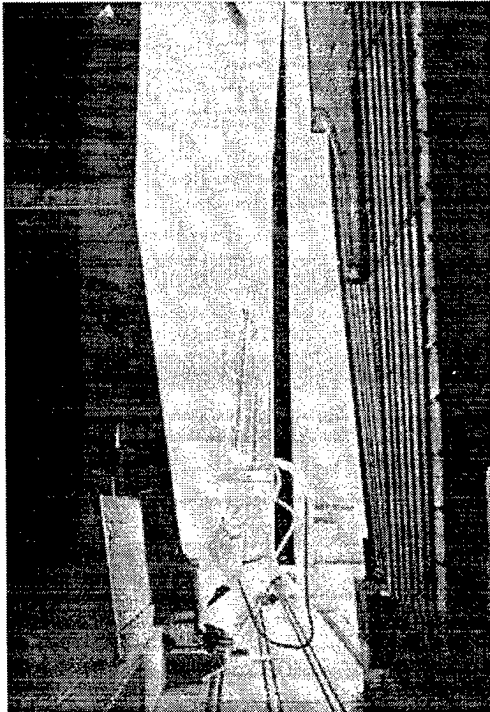
The partial failure of two sections of the hangar door, as seen in Figures 4.13, 4.14, and 4.15 was caused by wind acting normal to the door surface and weakness in the free edges of the door sections. Because of the secondary openings in the door sections, they did not have a continuous member along their free edge. This lack of a continuous member weakened the structural framing and the lighter secondary framing was unable to transfer the loads into the upper header and the lower rail seen in Figure 4.15. This failure was most likely not due to either a design or a construction deficiency but was simply an area of the structure that had little redundancy.

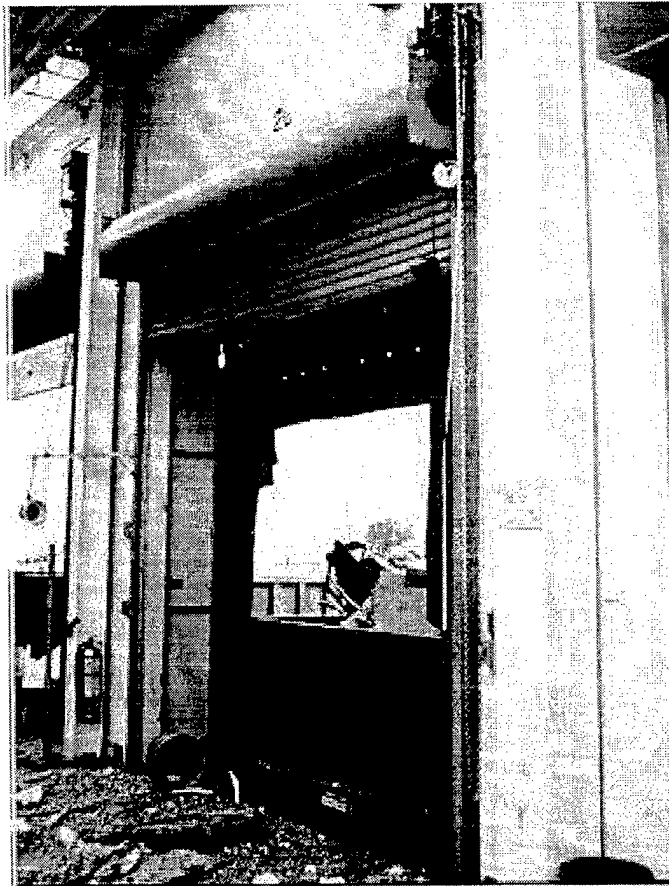
Figure 4.19 Undamaged Overhead Door

The main structural system performed well and sustained very little damage as did the large overhead doors, shown in Figure 4.19. The only damage to the main structural system was a horizontal crack in the CMU shear wall. The other element damaged was the corrugated steel roof decking. Approximately 80% of the corrugated steel roof deck was torn from the building. The damage mentioned can be seen in 4.20 and 4.21.

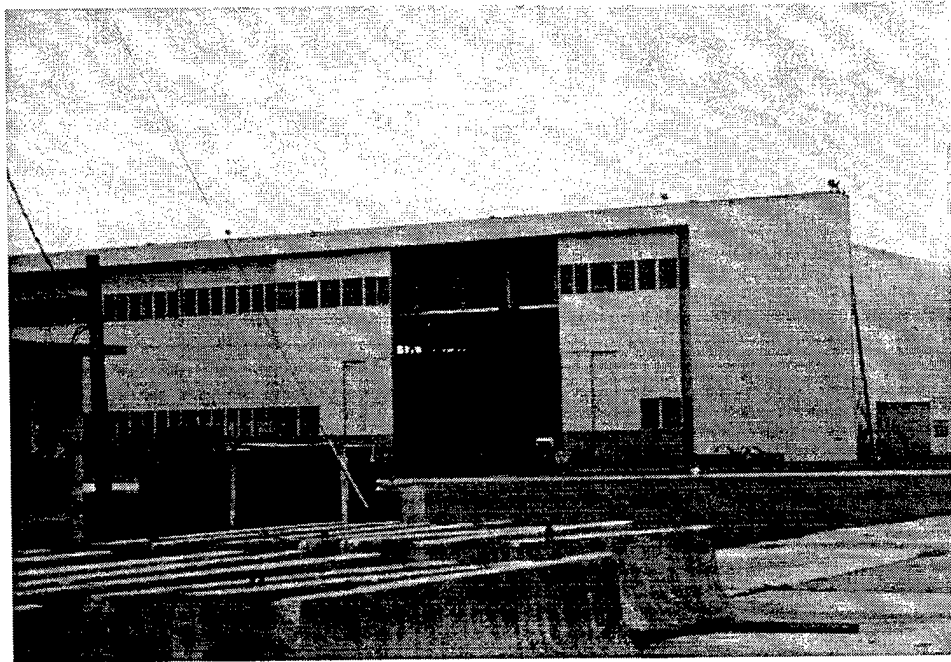
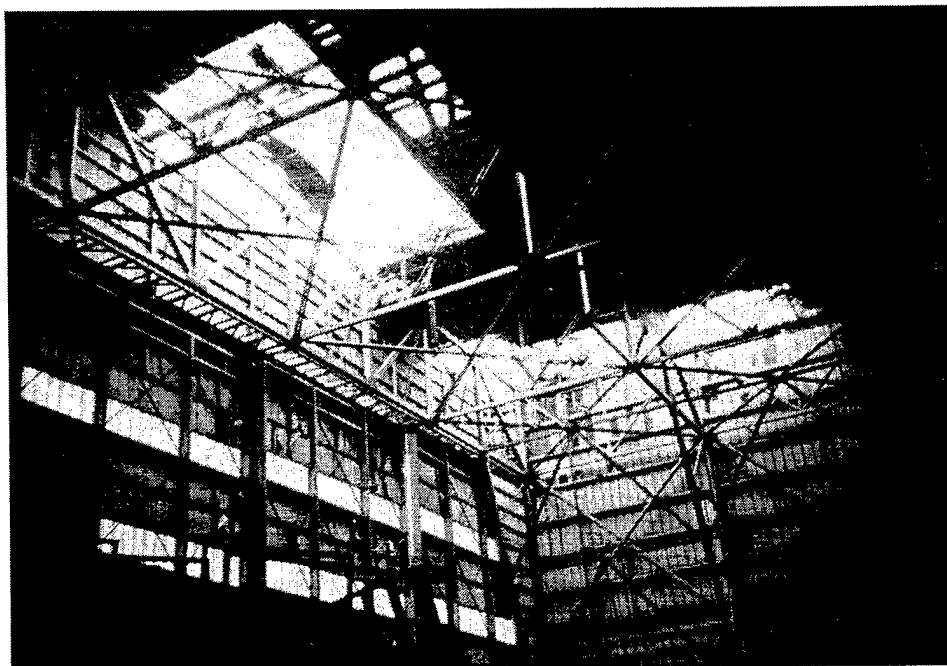
The only visible damage to this hangar is damage to the roof covering and decking. All of the structural members performed as designed, as did the corrugated metal siding. All of the windows in the structure remained intact, as did the hangar doors. These observations of the extent of the damage generally agree with the assessment by McDonald and Smith, 1990. The extent of the damage can be seen in Figures 4.22 and 4.23.

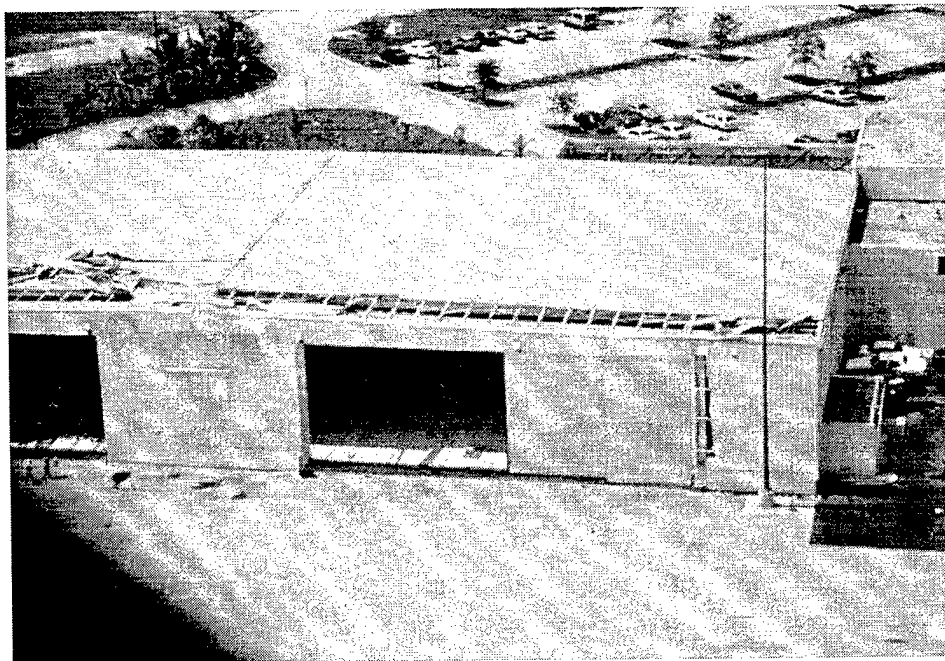
Figure 4.25 Elevation of Beechcraft Hangar

The main component that was damaged on all three hangars was the roof decking. The corrugated siding on the front of the Beechcraft hangar also received minor damage at the door pocket, see Figure 4.25.
